## Civilian Conservation Corps Restrooms

## Cultural Resource Brief

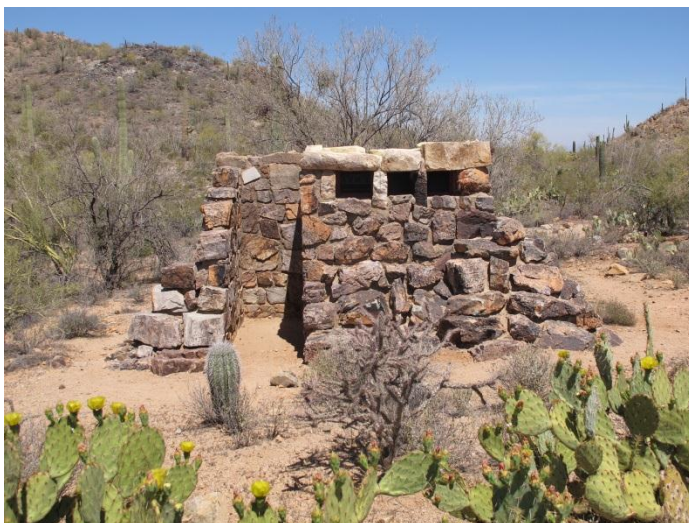
Women's restroom at Sus. Note skirt of stone around base of structure.

Some comfort stations are single units while others are double units. They range in size from 10 ft. by 6 ft. for single units to 17 ft. by 14 ft. for double units, and have walls up to 2 ft. thick. The walls of the comfort stations usually have a skirt of stone – the flaring out of the lower portions of the walls, which is exemplified by the women's comfort station at Sus. They had saguaro rib grills on the windows and roof.<sup>1</sup> Half the roof was "ceiled" and the other was covered with these saguaro ribs.<sup>1</sup> No two comfort stations are identical in construction, but the ones at Gates Pass and Ez-Kim-In-Zin are very similar. The comfort stations are located away from the activity area and blend in beautifully with their Sonoran Desert surroundings. They are wonderful examples of NPS Rustic Architecture (see Resource Brief on NPS Rustic Architecture).

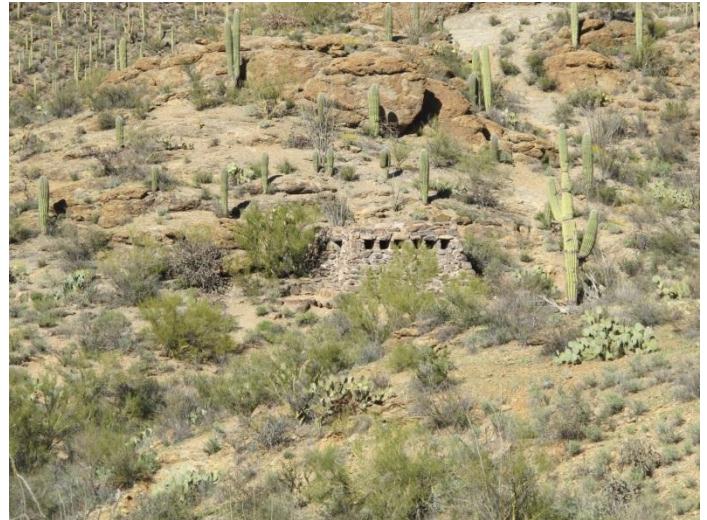
This CCC restroom is at Gates Pass in TMP. Note how beautifully the NPS Rustic architecture style blends in with the natural surroundings.

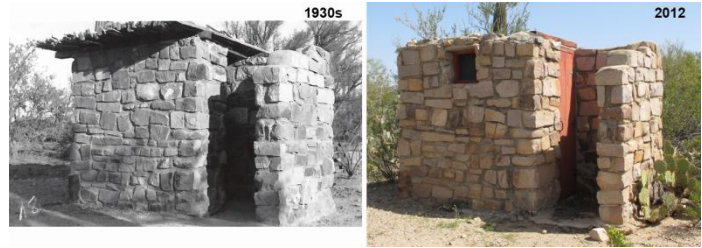
Comparative photographs, dated 1930s and 2012, of the CCC restroom at Signal Hill picnic area showing modifications made over the intervening years.

In 1961 when the Tucson Mountain District was added to Saguaro National Monument the Park Service began a program of rehabilitation. Toilet paper dispensers were installed in the restrooms and redwood doors were hung.<sup>2</sup> Dividers were also placed in all of the restrooms.<sup>3</sup> “Men” and “Women” signs were also installed at the Cam-Boh, Sus, and Signal Hill picnic areas.<sup>4</sup> At some point the saguaro rib roof was replaced with a solid roof and concrete floors were added.

The restroom that seems to have been modified the most is at Signal Hill. In addition to the modifications noted above, the Signal Hill restroom had a window put in through its west wall (see photograph at upper right).
